CIRCULAR Alert on detainable deficiencies

Following a recent Port State Control (PSC) inspection, four deficiencies have been imposed that resulted in the detention of the vessel. Dromon wishes to draw attention to these detainable deficiencies to avoid re-occurrence.

C18053 | 23 November 2018

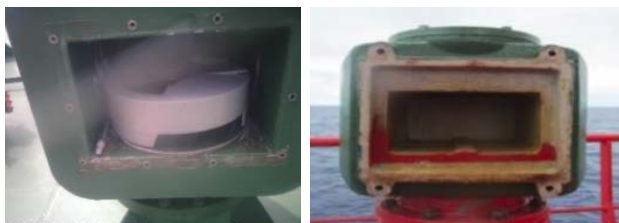
Another remark under this deficiency was that *“the ventilation head port side fwd was found destroyed during the inspection due to severe corrosion”*

The most probable cause of defective vent heads is the daily exposure to the outdoor environment on deck, occasional sprays from green seas and ballast water being pushed through the vent head during heavy rolling.

Malfunctioning air vent heads are a common finding, for the Port State Control inspector. Each vent head is an essential safety feature on board and should be kept in good condition. A broken air vent head will most probably result in a PSC deficiency which must be rectified before leaving port.

Shipowners / Managers / Operators should ensure that there is a regular inspection and maintenance programme in place for the air vent heads on board their vessels. Such programme should include the general condition (rust, dirt, functionality) and especially the condition of the float/ball/disc, guiding pin, seat and wire mesh (if installed). Needless to say, that a vent head replacement shall be of an approved type and any replacement parts shall be of the original or an equivalent quality. Also, a cheap air vent head can become an expensive experience. Air vent heads made out of aluminium or other grades of stainless steel have become increasingly popular in the last few years. Such materials are options to be considered in order to achieve a more maintenance-free vent head.
