USCG Safety Alert on ‘BilgMon 488’ Bilge Alarm

C19032 | 26 August 2019

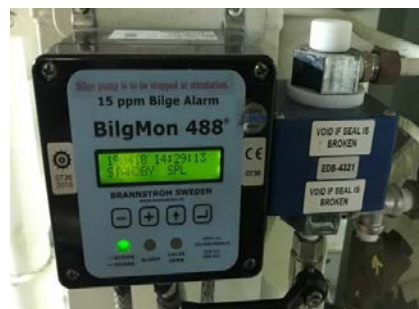
The specific monitor in these cases was the BilgMon 488 model manufactured by Brannstrom, a Swedish company. The older model, BilgMon 488 shown on the right, has a battery that is not replaceable by the crew inserted behind the circuit board of the Bilge Alarm. The purpose of the battery is to maintain the stored data and Real Time Clock (RTC) when the unit is disconnected from a power supply. The circuit board contains two contact points which provide the ability to measure the battery voltage. In all four cases, the battery voltage was extremely low and failed to provide the required 2.5 volts necessary to maintain the stored data without error.

As a result, when the data was viewed on the LCD screen it was scrambled and inaccurate. The operator's manual for this model clearly states that, under no circumstances should the battery be removed. Furthermore, a red warning sticker is affixed to the circuit board as pictured above. Attempting to remove the battery in this circumstance may cause an unrecoverable error, failure and data loss. A manufacturer's representative indicated that the battery was originally designed to last the lifetime of the device and that if the RTC stops due to a power supply failure combined with a low back-up battery voltage, the unit is locked down and the display reads "RTC check: FAILED." Click [here](#) for the applicable manual.

Ship owners / Managers / Operators whose vessels use the BilgMon 488 should remind vessel engineers to routinely review the stored data available through the LCD display ensuring that the data matches the information recorded in the ORB and actual OWS operations; and to maintain awareness that Port State Control Officers performing MARPOL examinations will verify that the BilgMon 488 is recording data properly and is aligned with the ORB entries. Avoid potential departure delays.

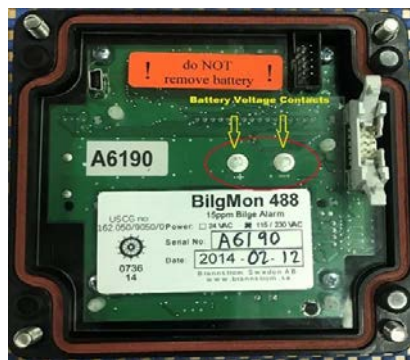
The newer model BilgMon 488 is equipped with a replaceable battery shown on the right below the yellow arrow. As a result, when the battery weakens the unit display will read "Batterylow: 0.5V Replace battery." The battery can then be safely removed because it utilizes a capacitor that ensures enough energy to maintain the stored data for several hours. Click [here](#) for the applicable manual.
