TECHNICAL PUBLICATION

Detainable deficiencies

guidance

December 2021

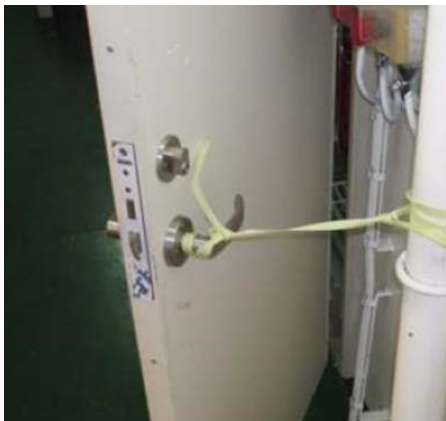
PSC Detainable Deficiency

The engine room and paint storeroom access self-closing doors were inoperative due to malfunctioning of self-closing devices and were back lashed in open position. Also, all self-closing fire doors on board were not closing properly.

According to MSC.1/Circ.1432, the fire doors should follow the below maintenance programme:

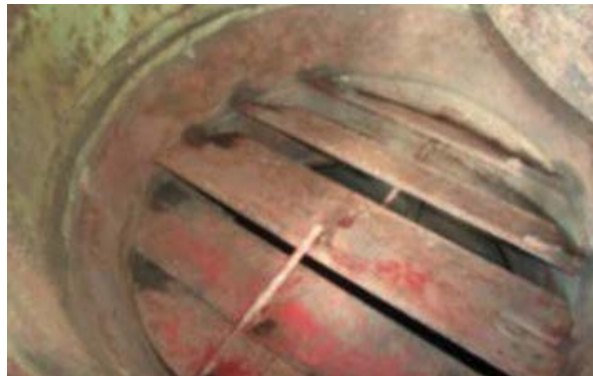
PSC detainable deficiency

Both ventilation flaps on board were in a bad condition. It is very important to note that:

- Fire dampers must be in a good working condition, functionally tested and examined both internally and externally;
- The maintenance and inspection of the fire dampers is conducted in accordance with the Safety Management;
- System (SMS) requirements based on Dromon Circular C13016;
- Damper flaps must be structurally sound with no wastage;
- The external ventilation trunk must be marked to show damper flag position “OPEN” or “CLOSE”; and
- The location of fire dampers must be clearly shown on the approved fire control plan.

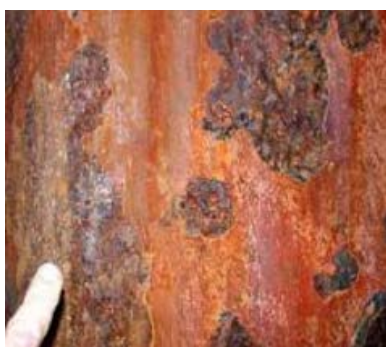
PSC Detainable Deficiency

The bulkheads between cargo holds were corroded. In usual cases, excessive corrosion may be found in the following locations:

- At the mid-height and at the bottom of the bulkheads. The structure may look in deceptively good condition but in fact may be heavily corroded. The corrosion is created by the corrosive effect of cargo and environment, in particular when the structure is not coated;
- Bulkhead plating adjacent to the shell plating;
- Bulkhead trunks which form part of the venting, filling and discharging arrangements between the topside tanks and the hopper tanks;
- Bulkhead plating and weld connections to the lower/ upper stool shelf plates and inner bottom; and
- In way of weld connections to topside tanks and hopper tanks.

If coatings have broken down and there is evidence of corrosion, it is recommended that random thickness measurements be taken to establish the level of diminution. Where the terms and requirements of the survey dictate thickness measurement, or when the Surveyor deems necessary, it is important that the extent of the gauging be sufficient to determine the general condition of the structure.

When the reduction in thickness of plating and stiffeners has reached the diminution levels permitted by DBS, the wasted plating and stiffeners need to be cropped and renewed.

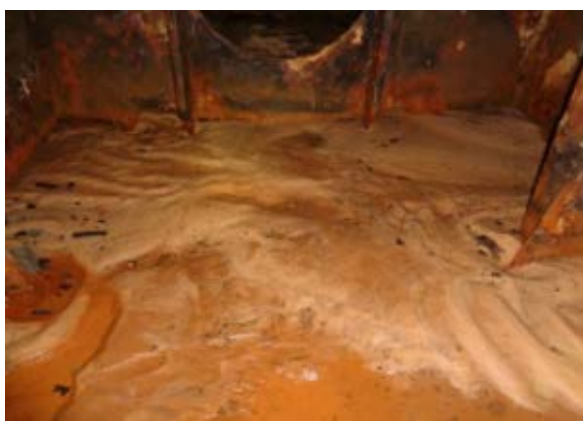
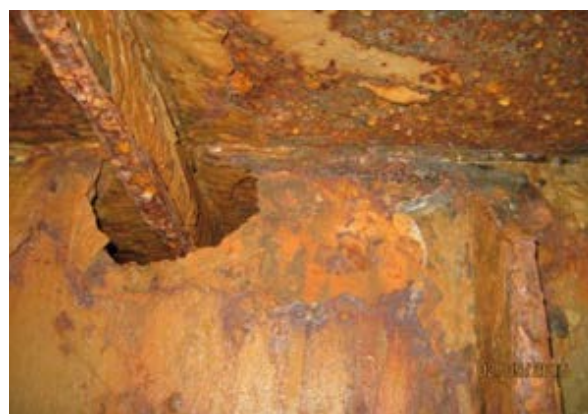
PSC Detainable Deficiencies

During the PSC inspection it was noted that cargo holds bottom were holed to DB and side ballast tanks. The marine environment, the humid atmosphere due to the water vapour from the cargo in cargo holds, and the high temperature on deck and hatch cover plating due to heating from the sun may result in accelerated corrosion of plating and stiffeners making the structure more vulnerable to the exposures described above.

Possible cause of damage are the general levels of corrosion and presence of stress concentration. Corroded/ fractured plate should be cropped and renewed with plating of enhanced thickness.

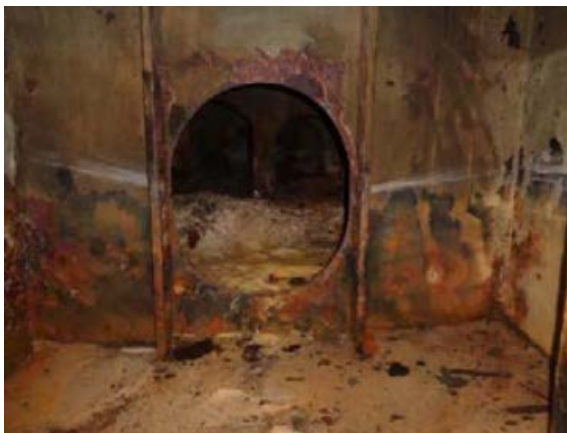
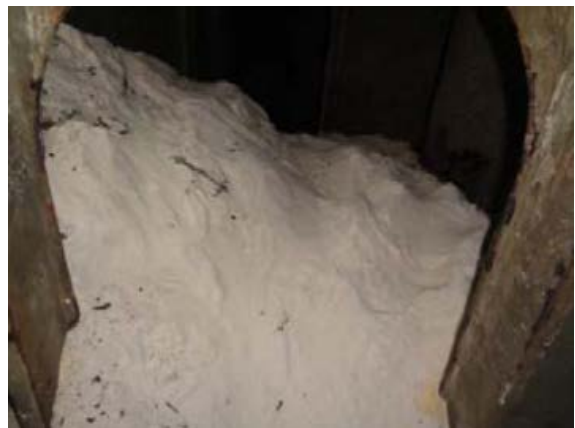
PSC Detainable Deficiencies

On board the vessel, the winch opening for cargo holds covers found corroded. In several respects, a winch shall be maintained in the same way you maintain a windlass. Inspect the friction brake linings regularly and replace them when necessary. Take steps to prevent oil or grease from accumulating on the brake surfaces. Periodically check the operation of brake-actuating mechanisms, latches, and pawls.

Frequently inspect winch drums driven by friction clutches for deterioration of the friction material. Check also to see if oil and grease on the surface is causing improper operation. Lubricate the sliding parts of positive clutches properly. Check the locking device on the shifting gear to see if it will hold under the rated load.

- All grease nipples on winches, should be attended weekly.
- Inspection on additional equipment such as chains, rings, hooks, blocks and shackles every three months.
- A thorough overhaul of the above equipment every 6 months.

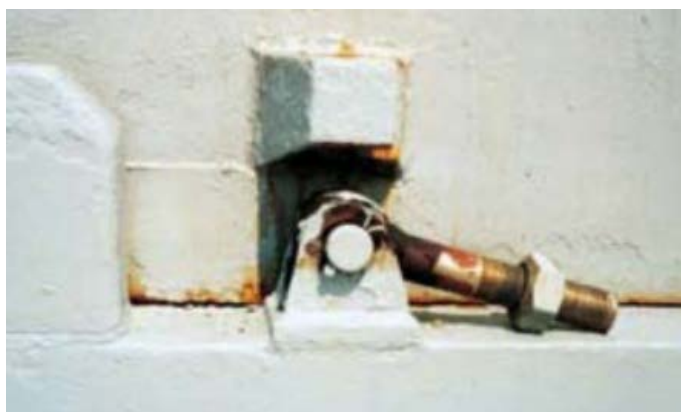
PSC Detainable Deficiency

In another PSC report, it was indicated that **the Covers have been found to be not as required**. As per the ship's ILLC Record of Conditions of Assignment the hatchway on main deck and sheltered deck were in position 1 and 2 and such covers should be weathertight and fitted with gasket and clamping devices as per ILLC Regulation 16. One cover was not provided with gaskets and another one was equipped with gasket. Weathertightness test failed for both covers.

1. normal wear and tear of the hatch cover system: deformation of the hatch coaming or cover due to impact; wear of the friction pads where fitted; wear and tear of the cleating arrangement; or
2. lack of maintenance: corrosion of plating and stiffeners due to breakdown of coatings; lack of lubrication of moving parts; cleats, joint gaskets and rubber pads in need of replacement, or replaced with incorrect specification parts.

very shortly thereafter. Missing or damaged rubber packing's should be replaced immediately.

The cleats should be kept in good serviceable condition and correctly adjusted. Those and the wheels should be well greased. The hydraulic oil should be testes quarterly and correct oil levels should be ensured. Continuing and regular maintenance of hatch covers, and packing's is more effective and hence less expensive than sporadic inspection and major repairs.

The cleats should be never left unfastened prior proceeding to sea.

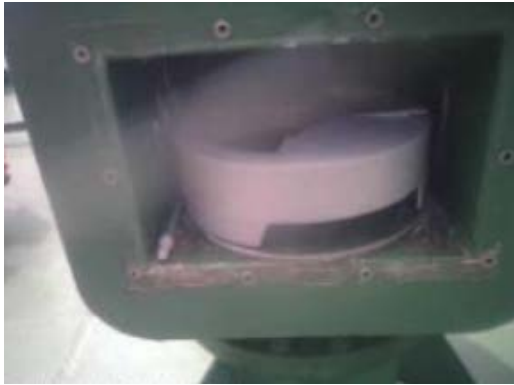
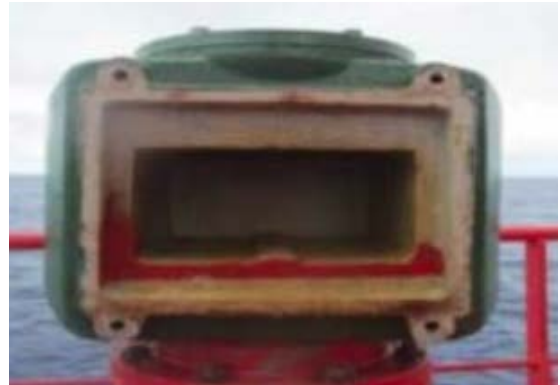
PSC Detainable Deficiencies

Another remark under this category was that the ventilation head port side fwd was found destroyed during the inspection due to severe corrosion.

Shipowners / Managers / Operators should ensure that there is a regular inspection and maintenance programme in place for the air vent heads on board their vessels. Such programme should include the general condition (rust, dirt, functionality) and especially the condition of the

float/ball/disc, guiding pin, seat and wire mesh (if installed). Needless to say, that a vent head replacement shall be of an approved type and any replacement parts shall be of the original or an equivalent quality. Also, a cheap air vent head can become an expensive experience. Air vent heads made out of aluminium or other grades of stainless steel have become increasingly popular in the last few years. Such materials are options to be considered in order to achieve a more maintenance-free vent head.
