USCG Safety Alert on ‘BilgMon 488’ Bilge Alarm

C19032 | 26 August 2019

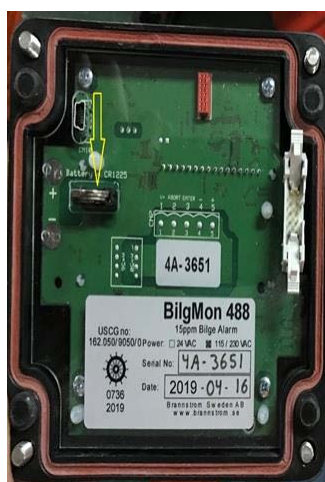
To identify what model you may have note that the older type of master unit has serial numbers starting with "A," "AE," "BFA," and "EDA." The newer type of master unit has serial numbers starting with "4A," "4AE," "4BFA," and "4EDA." Click [here](#) for information on how to locate these numbers.

Ship owners / Managers / Operators whose vessels use the BilgMon 488 should remind vessel engineers to routinely review the stored data available through the LCD display ensuring that the data matches the information recorded in the ORB and actual OWS operations; and to maintain awareness that Port State Control Officers performing MARPOL examinations will verify that the BilgMon 488 is recording data properly and is aligned with the ORB entries. Avoid potential departure delays.
